Forty-Eighth Annual Field Conference

April 28, 1973

ASPECTS OF THE ENGINEERING-ENVIRONMENTAL GEOLOGY
IN THE LOWER CUYAHOGA RIVER VALLEY,
OHIO

GEORGE D. GARDNER
GENERAL ANALYTICS, INC.

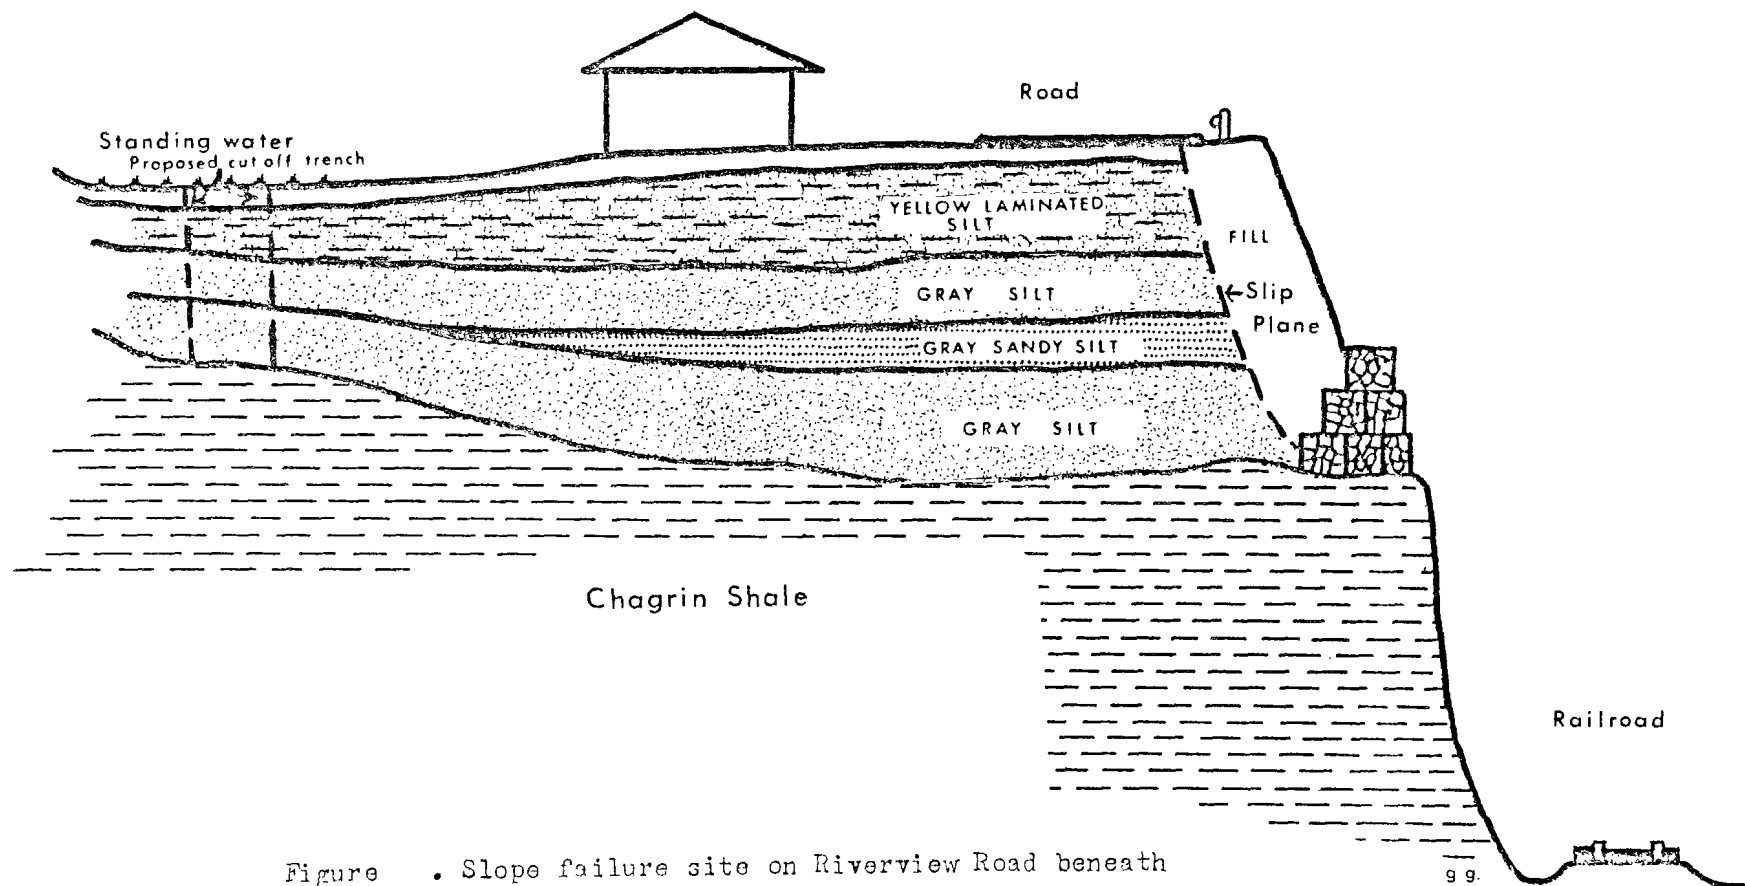
A landslide on Riverview Road beneath the Ohio Turnpike bridge has repeatedly mobilized and disrupted the road and railroad. Sliding involved activation of interbedded gray silts and clays (CL, CL-ML, ML), yellow-brown silts (ML), and gray silty sand (SM). Mobilization has occurred along steep, nearly vertical slip planes (see accompanying diagram). Reference to the U.S.C.S. Properties tables indicates that most of the soils in the profile (ML, SM, CL-ML) have medium to low permeabilities, poor resistance to shear deformation, only fair shearing strength, and possible piping problems. Examination of the adjacent, foliated slope reveals no apparent instability problems, yet the conditions on this slope are almost identical to those on the slope which has repeatedly failed. The dilemma is more clearly understood when the history of the site is known. The first instance of slope instability occurred shortly after wind-damaged trees were

removed (pushed over). The trees aided slope stability by sapping water from the soil, and actually binding the slope together. The shearing strength of the soils was probably weakened by the ground disturbance when the trees were overturned, and by removal of the binding ability and sapping functions of the roots. Another factor was the addition of water into the groundwater flow system of the slope by runoff from the Ohio Turnpike bridge. Pipes and ditches from the bridge empty into the low area behind the slope (note the presence of cat-tails). The effect is to increase the seepage levels above those experienced before construction of the bridge. Thus, the geologic, geohydrologic, and behavioral characteristics of the soils were conducive to failure. The removal of the trees, ground disturbance and increased pore water pressures acted in concert to trigger the first slope failure. Initially, the failure also may have been enhanced by piping which later propagated the larger rotational slide by undercutting the slope.

Following the first failure, the slide scar was refilled behind pyramidal-shaped rock-filled cribs. The fill material was the debris from the previous slide. During the late winter, water seeped along bedding planes in the silts and silty sands until it met the semipermeable fill material at the old slip plane. The fill became saturated along this plane, pore water pressure increased, and the slope failed again, removing

Figure . Slope failure site on Riverview Road beneath
the Ohio Turnpike bridge.

part of the road and burying a section of the railroad.

The method suggested to correct the slide conditions was to intercept the ground water seepage with a cutoff trench parallel to the slope at the crest, and to redirect surface drainage from the Turnpike. A layer of gravel placed horizontally at the base and vertically up the scar was also recommended to improve the long-term stability of the slope by reducing pore water pressures.

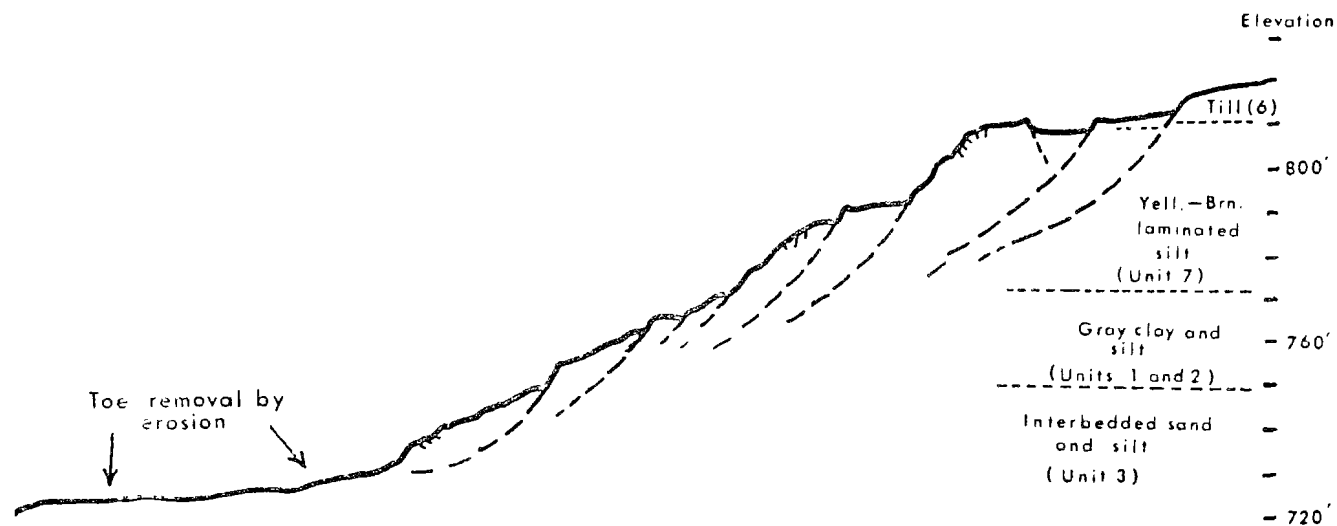
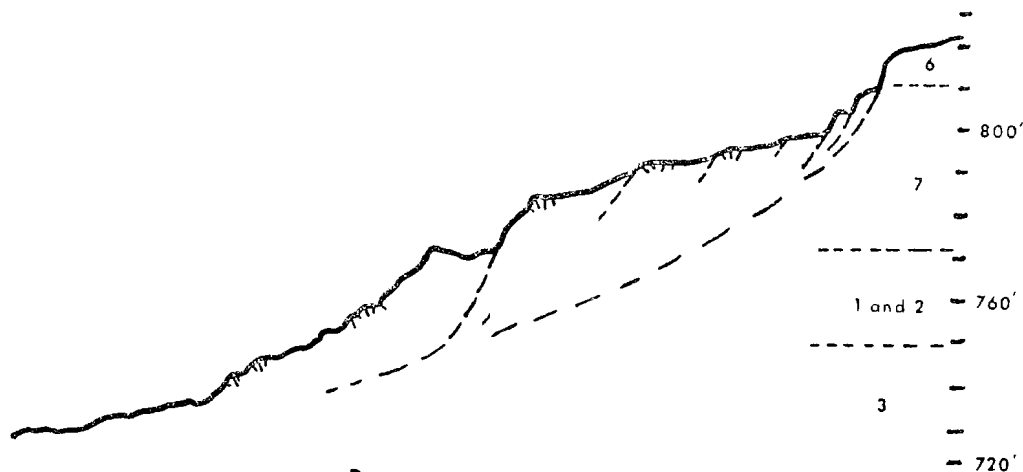
Field evidence indicating active movement on this slope is multifold. The ground surface is scarred with numerous tension cracks and slide scarps. The lineations caused by these scars are quite apparent on airphotos. The attitudes and trunk shape of the trees typify those on slumping slopes. The history of slide movement can often be deciphered from the trunks and growth patterns of the trees. The geology, determined by field observation, is similar to that seen at the other stops, and is likewise conducive to sliding. A highly generalized outline of the soil stratigraphy is given on the accompanying diagram. Sliding is, for the most part, rotational and retrogressive in nature, with the major shear surface estimated to have a maximum depth of 40', lying at approximately 19° from the horizontal (which, coincidentally, is the laboratory determined residual angle of internal friction). Sliding was probably initiated by oversteepening and undercutting the toe by the Cuyahoga River which used to run along this flank of the valley before rerouting. Movement is continued by undercutting the toe by headward eroding intermittent

valleys, with the possibility of piping in the sand units at the base of the slide. Increased pore water pressures during the wet season also plays a key role in slide activation. Excavation of the impermeable till above the slope for Turnpike fill enhances the seepage by exposing the silty soils and providing for water impoundment in the recharge area. Absence of trees, which can sap significant volumes of water, also enhances seepage and pore water pressure effects.

As one can see, the entire slope is mobilized. The extent of slope mobilization in the area typifies movement on many other slopes within the valley. A small "bump" on the road may actually be a small part of an extensive slide system, such as seen on Boston Mills Road. Other roads with similar conditions include Highland Road, Columbia Road, Yellow Creek Road, and others. If these conditions were recognized and anticipated in planning the construction of the various roads and Interstates which cross the valley, man hours, materials, costs, and delays may have been reduced considerably.

Figure . Two profiles of the east valley wall just south of the Ohio Turnpike bridge.
